Environment, Health and Safety (EHS) Gap Assessment

Tabasco Floods, Mexico 2007

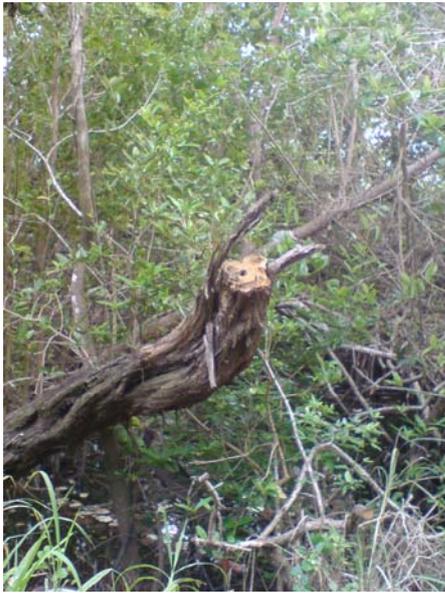
Although no information was made available on the spill characteristics and the clean-up operations, a subsequent site visit did not reveal significant hydrocarbon impact to the beaches. However, damage to mangrove forests, principally for use as fuel, was identified in a coastal area outside of El Belotte, which may reduce the capacity of the mangroves to act as natural buffer to storm surge. In addition, the area of Playa de Caracol is suffering from significant beach erosion.

Photograph 1: Mangrove damage de in area of El Belotte

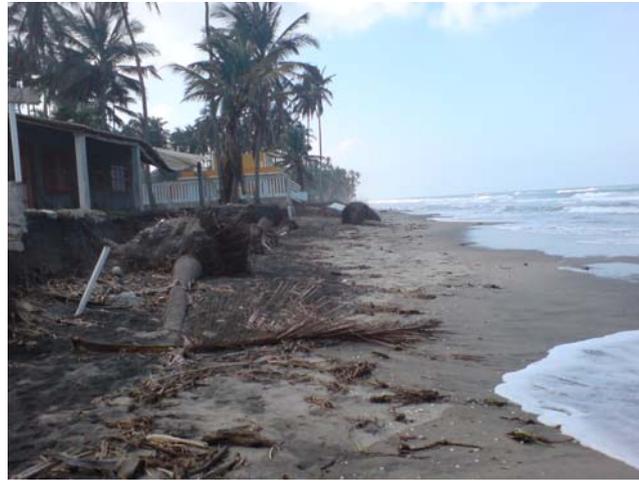
Photograph 2: Coastal erosion in area of Playa Caracol

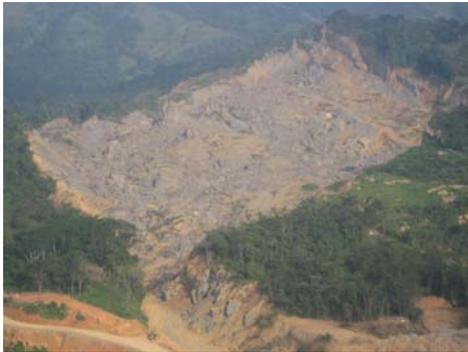
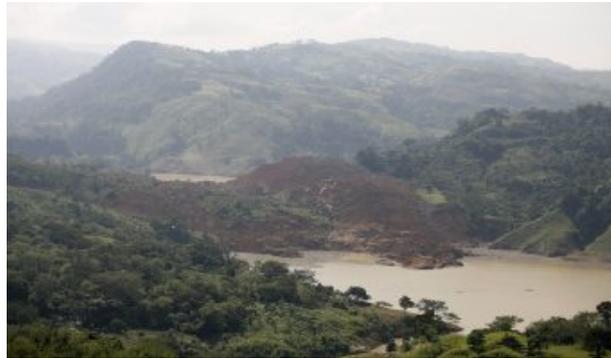
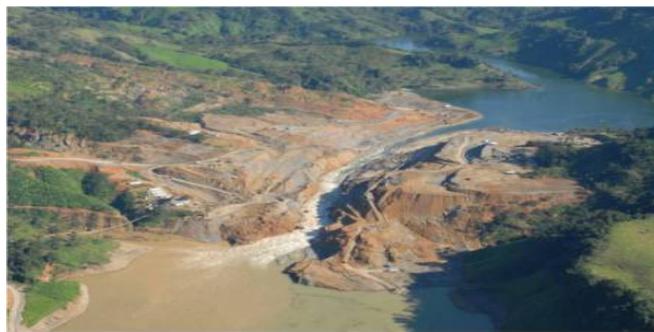
On 5 November 2007, a landslide hit the village of Juan del Grijalva, approximately 70km south-west of Villahermosa, interrupting the flow of the Río Grijalva between the Peñitas and Malpaso reservoirs. The landslide struck the Río Grijalva river causing a wave that devastated over 100 homes, causing 14 deaths with 11 missing^{xvi}. The resulting blockage caused the Rio Grijalva to back-up forming a temporary lake.

Photographs 3- 5: Rio Grijalva Landslide, Chiapas

Visual evidence indicates that the landslide occurred on a relatively shallow, sloping hillside, hence, the combination of sensitive receptor (reservoir) and unstable slopes combined with the likelihood of increased frequency and severity of climate change induced hydrometeorological events highlights the importance of assessing and managing the risk of catastrophic reservoir failure. It remains unclear whether the reservoirs in the Grijalva Hydropower Serial System have been impacted by enhanced sedimentation due to soil erosion and if this has a further risk implication.

During the first two weeks of December 2007, a channel was excavated through the barrier to allow the Río Grijalva to flow once again, reducing the risk of catastrophic failure. It was reported on 3 February 2008 that 967,166m³ of debris had been excavated and that the 2nd stage of the operation, which began on 8 January 2008, would widen the channel to 70m and allow a flow rate of between 900 and 1000m³ per second. The report also indicated that the channel has been excavated not only to facilitate storage control prior to the onset of the next rainy season but also to recover storage capacity (and presumably electricity production).

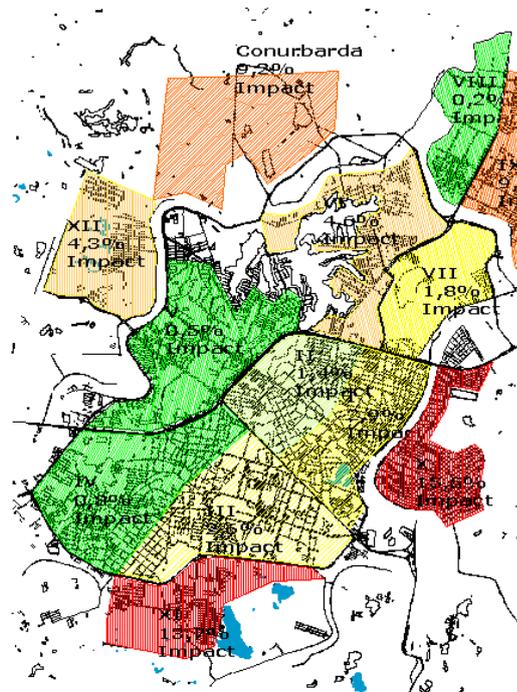
A preliminary flood impact map for Villahermosa indicates a strong correlation between impact and elevation, with those areas with elevations equal or below mean sea level (marked in red) exhibiting the highest impact.

Figure 6: Preliminary Impact Map of Villahermosa Indicating Extent of Housing Damage

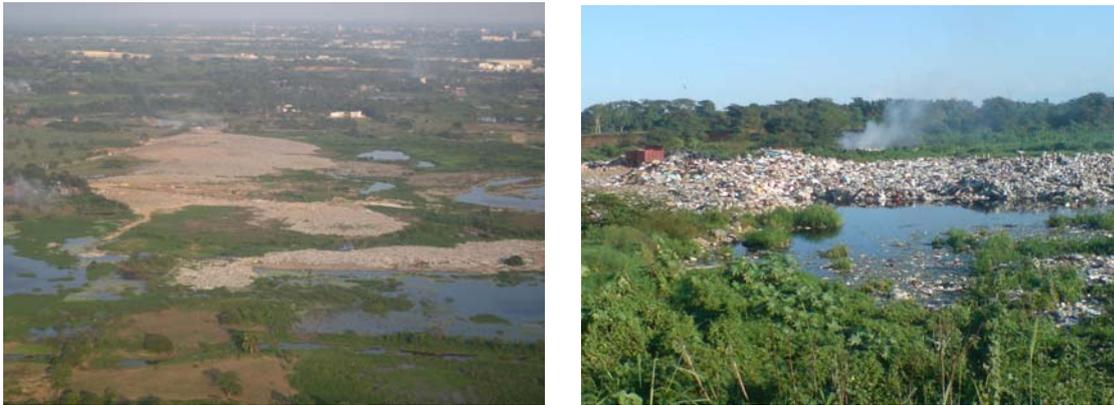
Photographs 6 and 7: Open dumps to the north-east of Villahermosa

Recommendations: There is an opportunity to include disaster waste management as a component in the proposed new civil protection regulations. It is recommended that a new disaster waste working group is established to develop policies and draft regulations including the need to prepare a disaster waste preparedness and management plan. In addition, the data held on hazardous waste producers (including PEMEX) at a Federal level should be made available at the State level and the SERNAPAM should include this information in the proposed environmental risk maps (see above). The SERNAPAM should undertake a capacity review to assess current logistical capacity (trucks, collection vehicles, etc.) and disposal facilities. Existing recycling capacities (private and public service provider, companies, NGOs) should be assessed and temporary disaster waste storage areas, which facilitates segregation and recycling at a later stage, identified and assessed. Improved public information – linked to specialist waste collection rounds – could facilitate better recycling and segregation of hazardous wastes.
