Environment, Health and Safety (EHS) Gap Assessment

Tabasco Floods, Mexico 2007

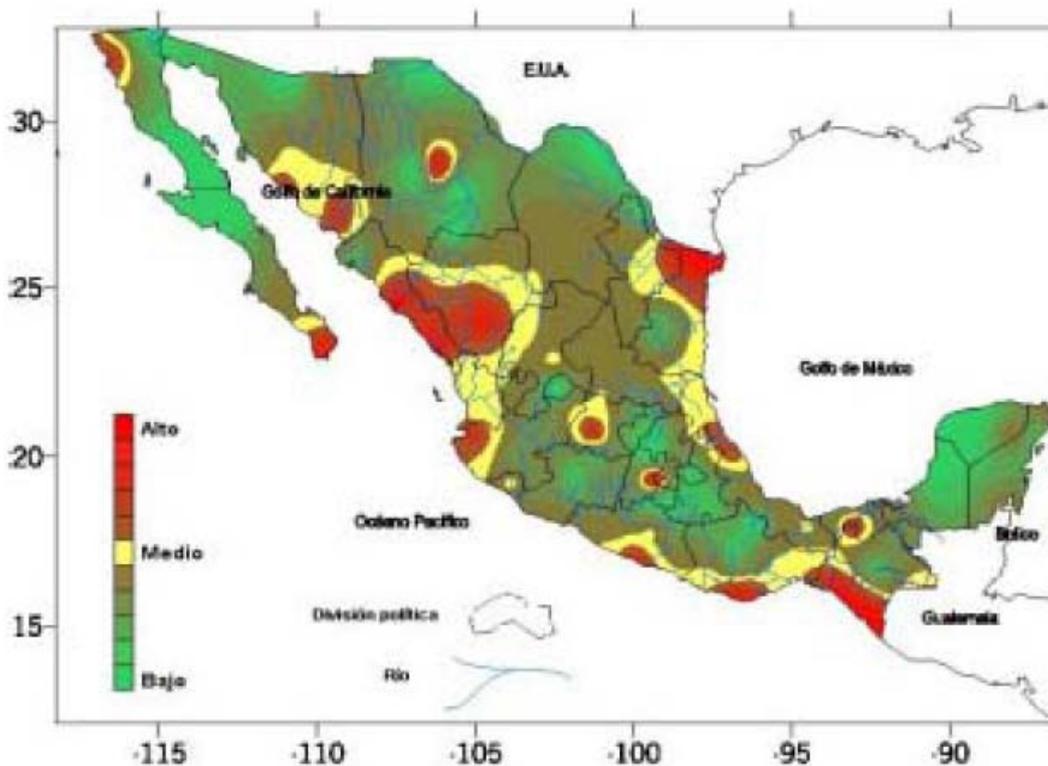
Figure 2: Flood Risk, Federal Republic of Mexico

The State is at high risk from impact by flooding, especially in the urbanised areas northeast of Villahermosa and the surrounding sub-region of Centro of Tabasco. The flood risk is based on high precipitation rates, deforestation in the upper catchment, shallow topographical gradients and poor flood management and early warning systems.

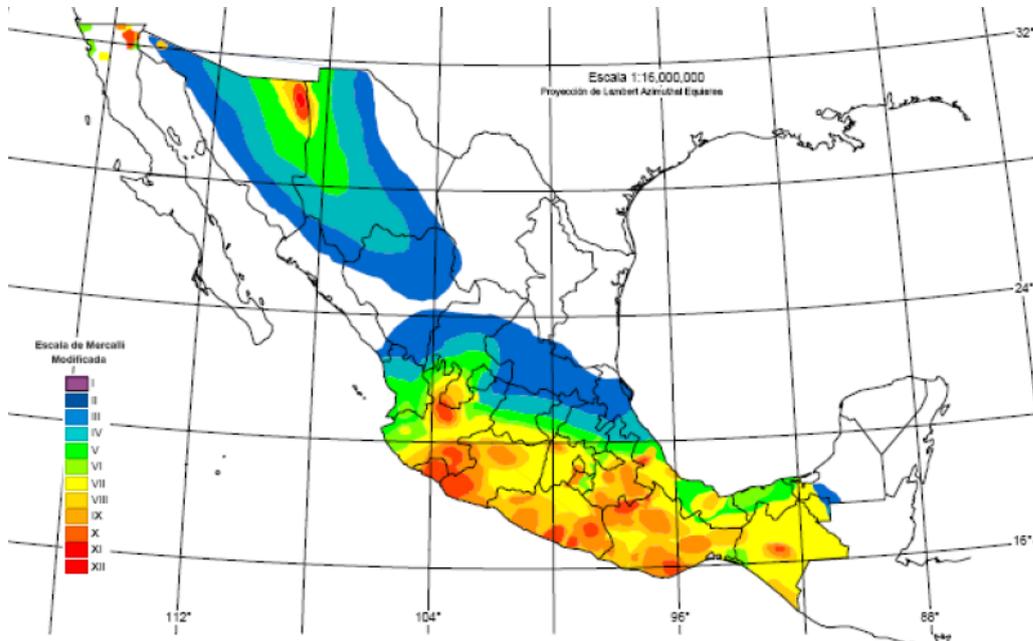
Figure 4: Seismic Risk Map, Federal Republic of Mexico (1845 – 1985)

The risk of direct damage from seismic activity is deemed low to moderate in the State of Tabasco. The latest information, provided by the National Centre for Disaster Prevention (CENAPRED), indicates that 7 earthquakes have been recorded with magnitudes of between 4.0 and 4.5 (Mercalli Scale) in some areas of the State during 2007. Between January 1968 and December 2007, 29 earthquakes were recorded in the State of Tabasco, with a maximum magnitude of 4.7. In addition, two earthquakes occurred in the neighbouring State of Chiapas (magnitude of 5.0 at epicenter) on 11 February 2008 and Oaxaca on 12 February 2008 (magnitude of 6.4 at epicenter), the latter causing noticeable tremours throughout the State of Tabasco.
